**Re: Reach MM Final Report-Settlement Agreement-Revision 1 No. V-W-11-C-
974 for The Tittabawassee River/Saginaw River & Bay Site
Dow Submittal Number T2.RMM.2012.001**

**Reach MM In-Channel Island Removal Action Final Report
The Tittabawassee River/Saginaw River & Bay Site**

**June 8, 2012
Dow Submittal Number: T2.RMM.2012.001**

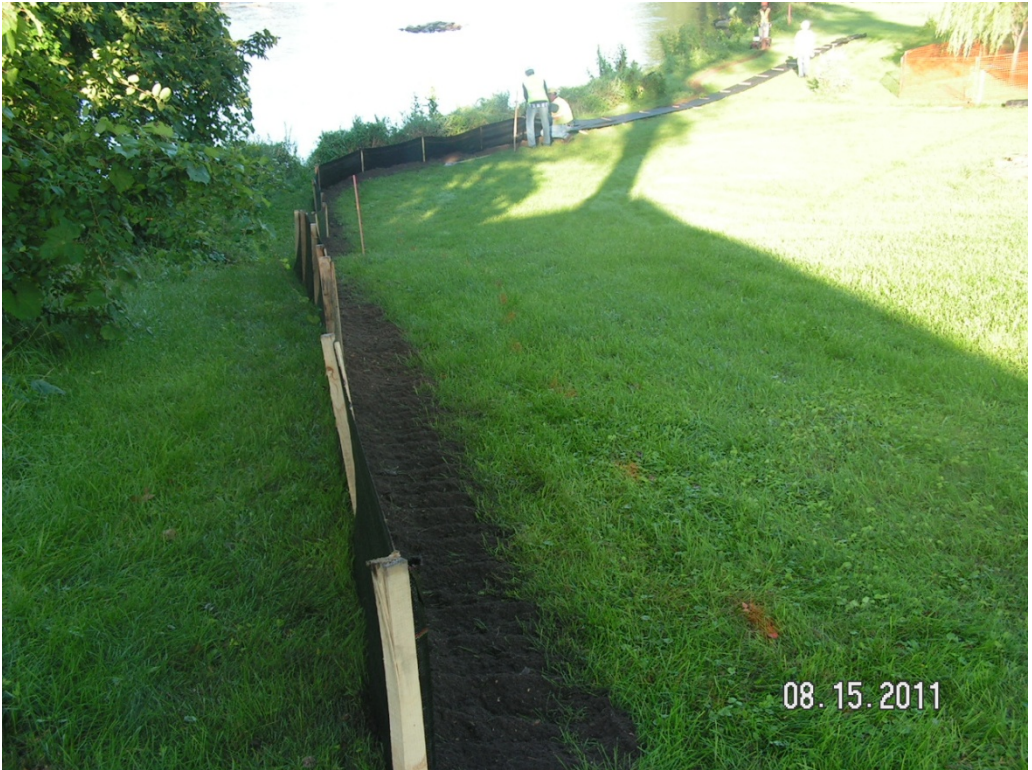
Client Name: Dow Chemical		Site Location: MM Island	Project No. 476
Photo No. 3	Date: 08/15/2011

Direction Photo Taken: Southwest			
Description: Installation of Soil Erosion & sedimentation controls (silt fence)

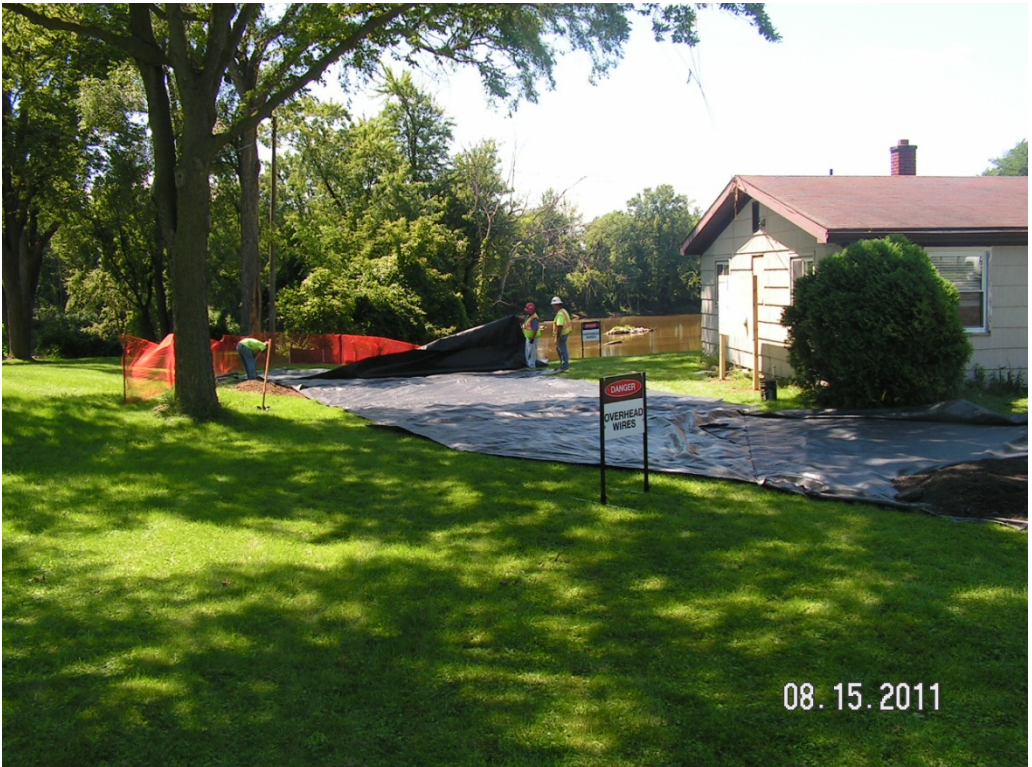
Photo No. 4	Date: 08/15/2011

Direction Photo Taken: Southwest		
Description: Installation of temporary woven geotextile to support asphalt millings used for temporary site access.

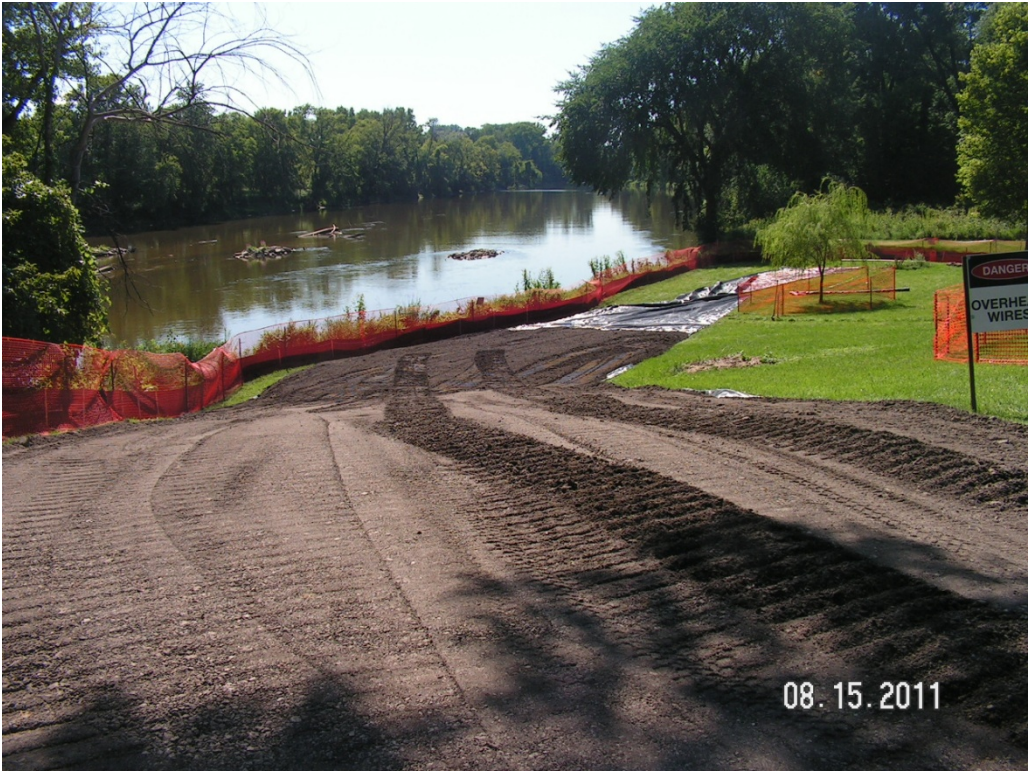
Client Name: Dow Chemical		Site Location: MM Island	Project No. 476
Photo No. 5	Date: 08/15/2011

Direction Photo Taken: Southwest			
Description: Temporary access road toward river and temporary laydown area.

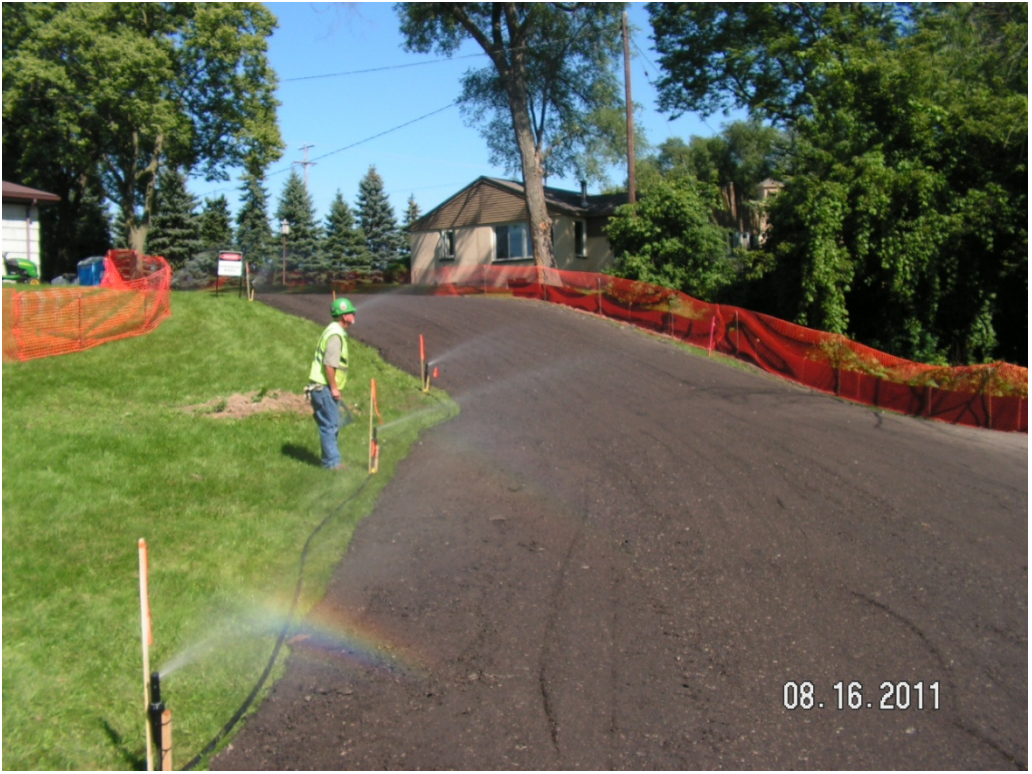
Client Name: Dow Chemical		Site Location: MM Island	Project No. 476
Photo No. 7	Date:

<p>08.16.2011</p>	
Direction Photo Taken: Northeast			
Description: Operation of dust suppression system for temporary access road.

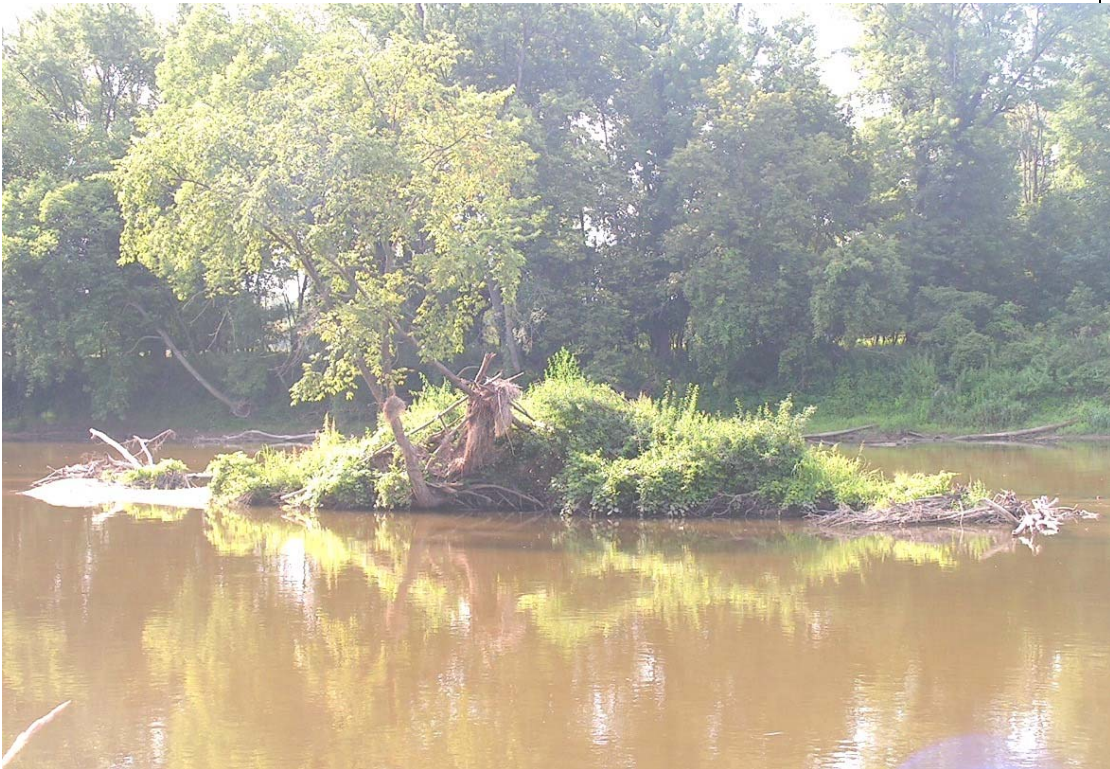
Photo No. 8	Date: 08/16/2011

Direction Photo Taken: South		
Description: Pre-Removal of MM Island

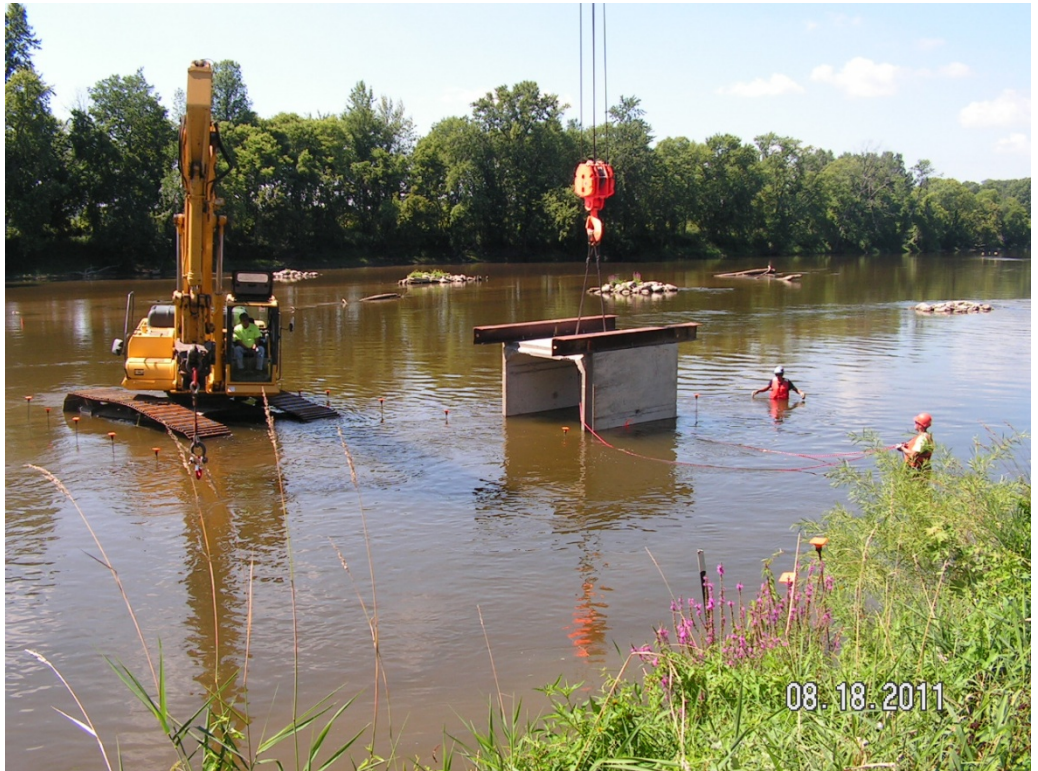
Crane placing first
bridge abutment

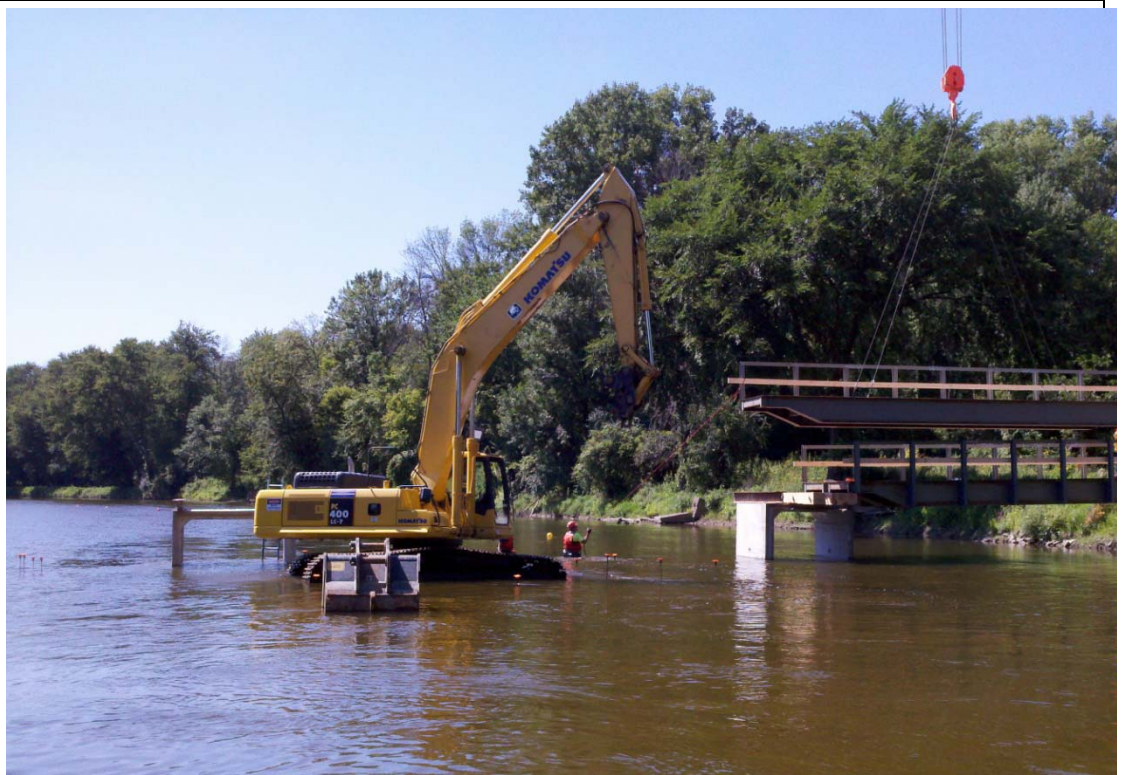
Photo No.
12

Placement of second
half of first bridge
section

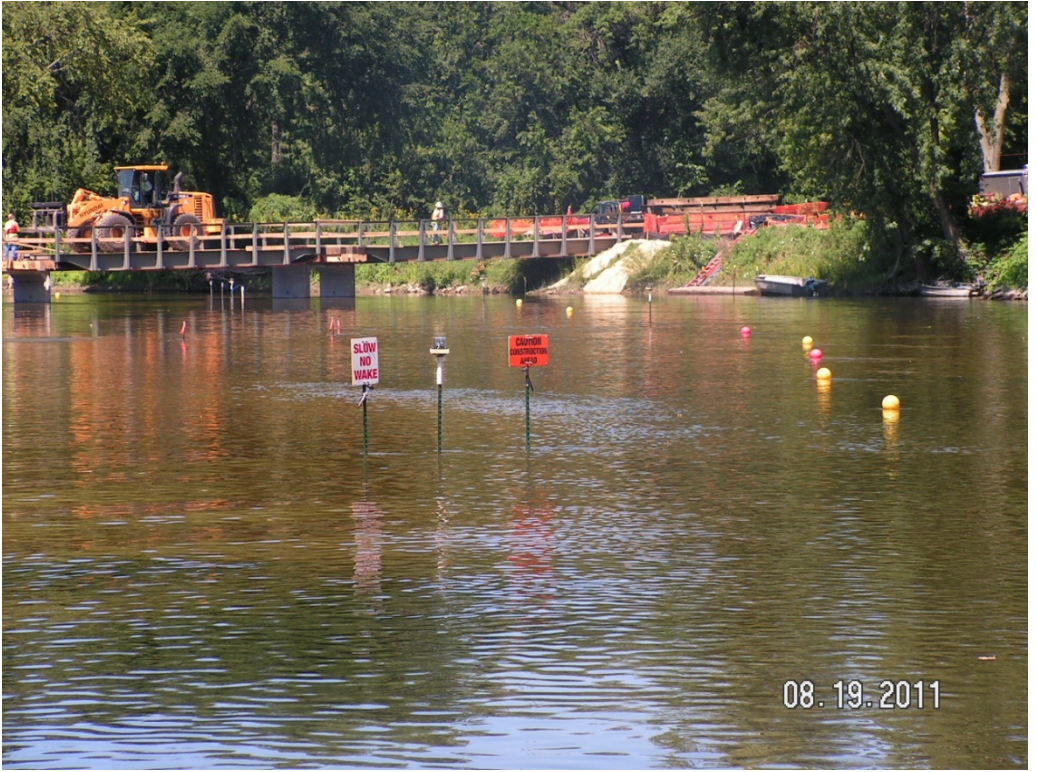
Client Name: Dow Chemical		Site Location: MM Island	Project No. 476
Photo No. 15	Date: 08/19/2011

Direction Photo Taken: Northwest			
Description: Looking upstream from boat downstream of MM Island and temporary bridge showing temporary signage and buoy placement for directing boat traffic

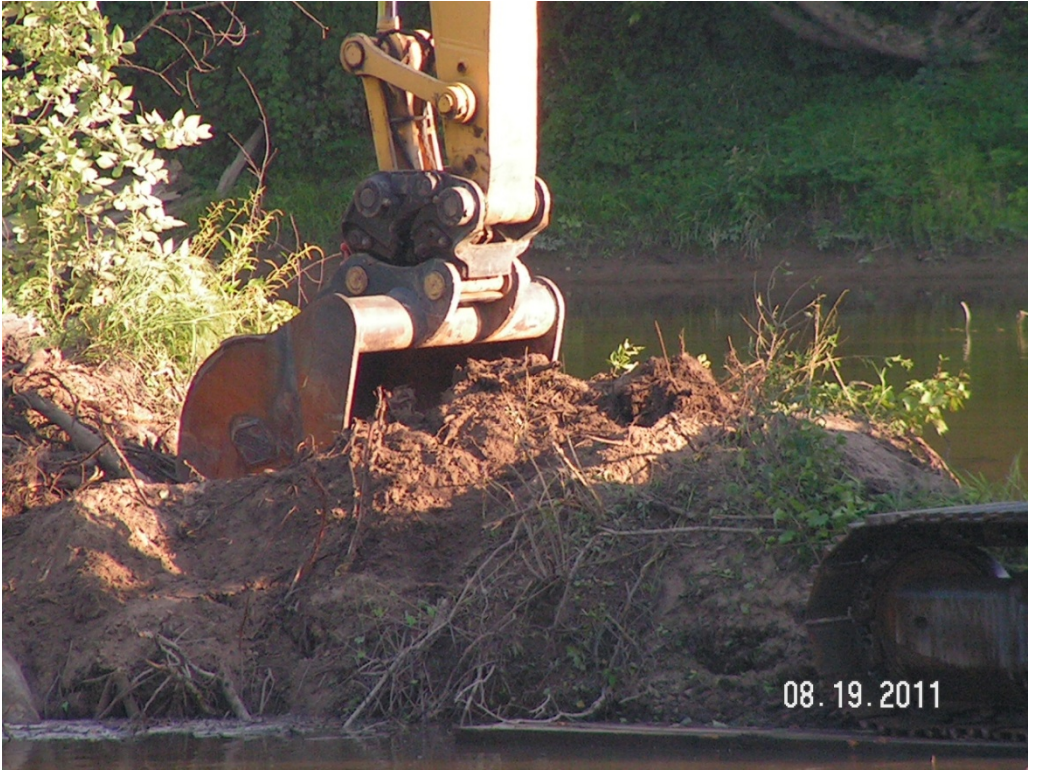
Client Name: Dow Chemical		Site Location: MM Island	Project No. 476
Photo No. 17	Date: 08/19/2011

<p>08.19.2011</p>	
Direction Photo Taken: Southeast			
Description: Excavator removing sediment/soil and woody debris for MM Island

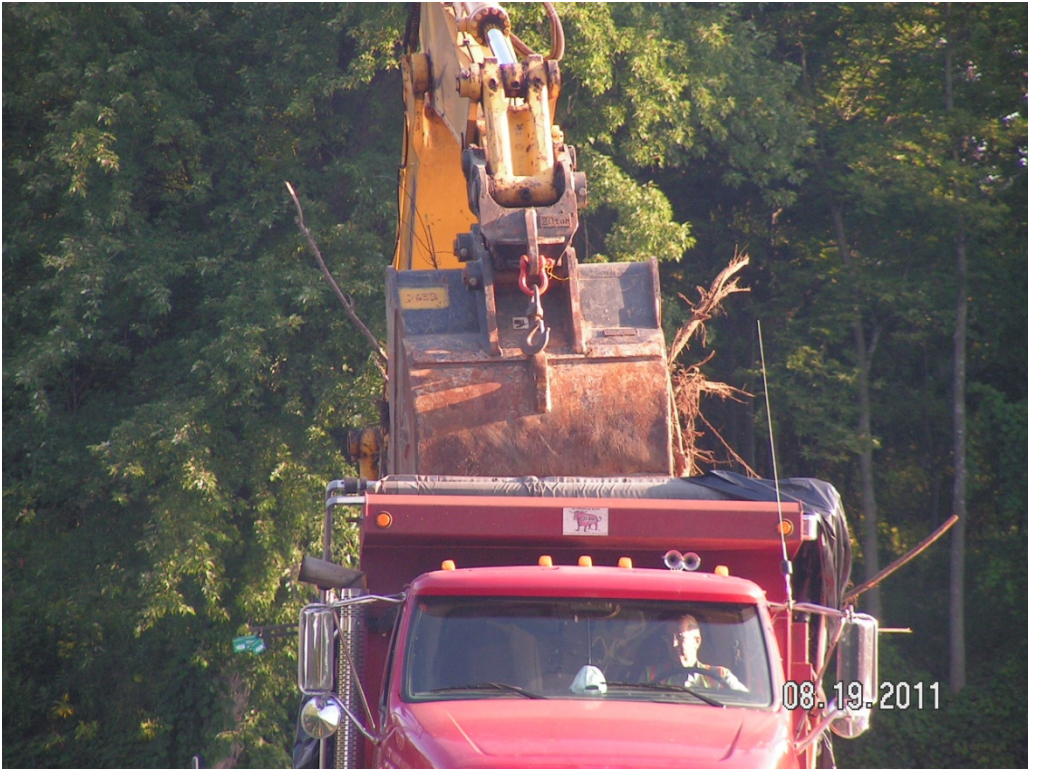
Photo No. 18	Date: 08/19/2011

<p>08.19.2011</p>
Direction Photo Taken: South		
Description: Excavator placing sediment/soil and woody debris into lined transport truck. Material to be sent to Peoples Landfill for disposal.

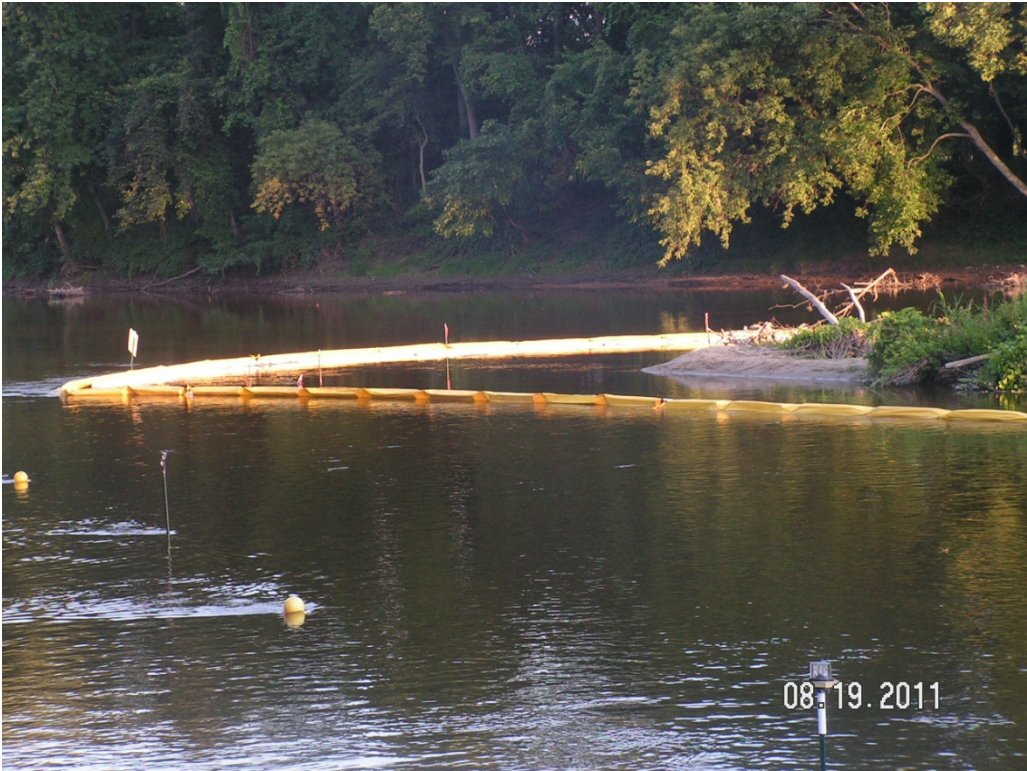
Client Name: Dow Chemical		Site Location: MM Island	Project No. 476
Photo No. 19	Date: 08/19/2011

Direction Photo Taken: Southeast			
Description: Downstream limits of MM Island prior to removal and showing silt curtain in place

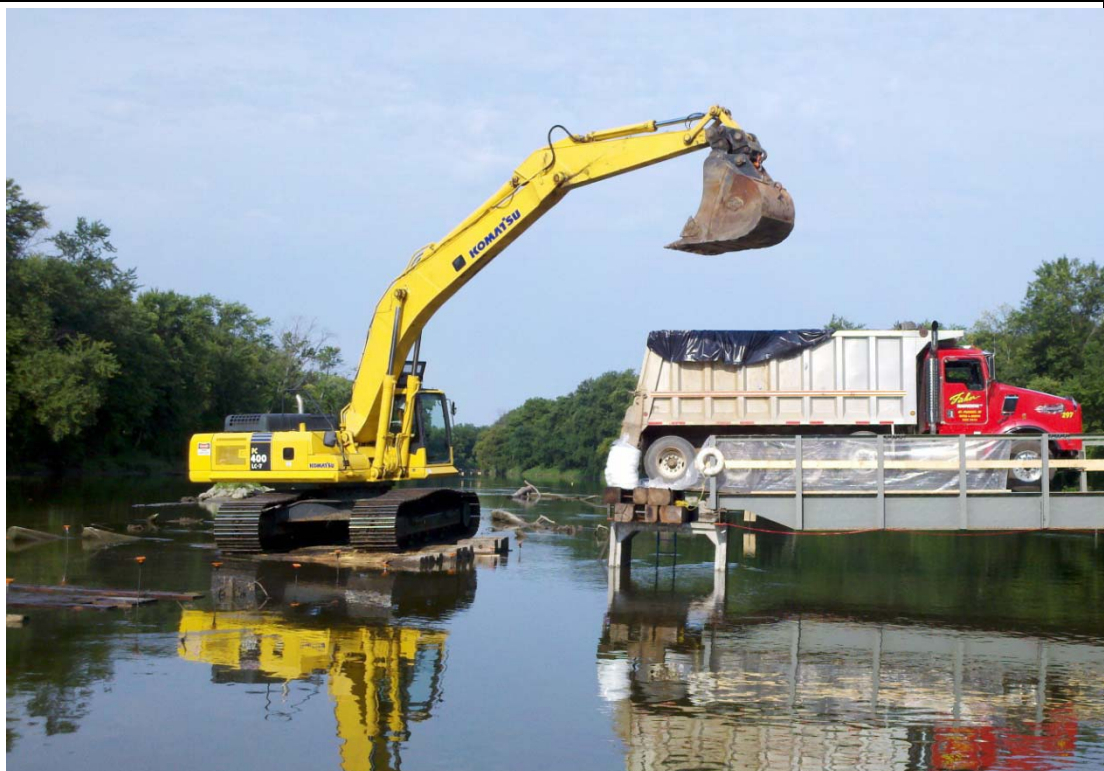
Photo No. 20	Date: 08/20/2011

Direction Photo Taken: West		
Description: Excavator placing MM Island sediments/soil & woody debris into lined transport truck.

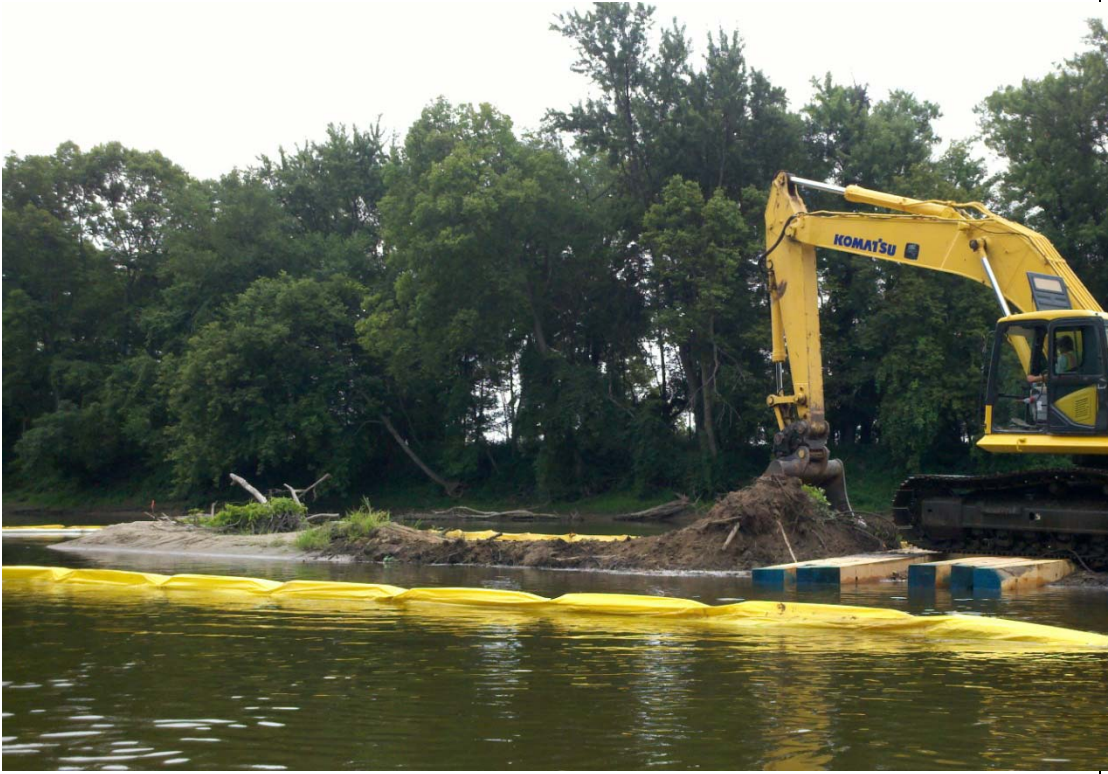
Client Name: Dow Chemical		Site Location: MM Island	Project No. 476
Photo No. 21	Date: 08/20/2011

Direction Photo Taken: Southeast			
Description: Excavator removing sediment/soils & woody debris from upstream limits of MM Island.

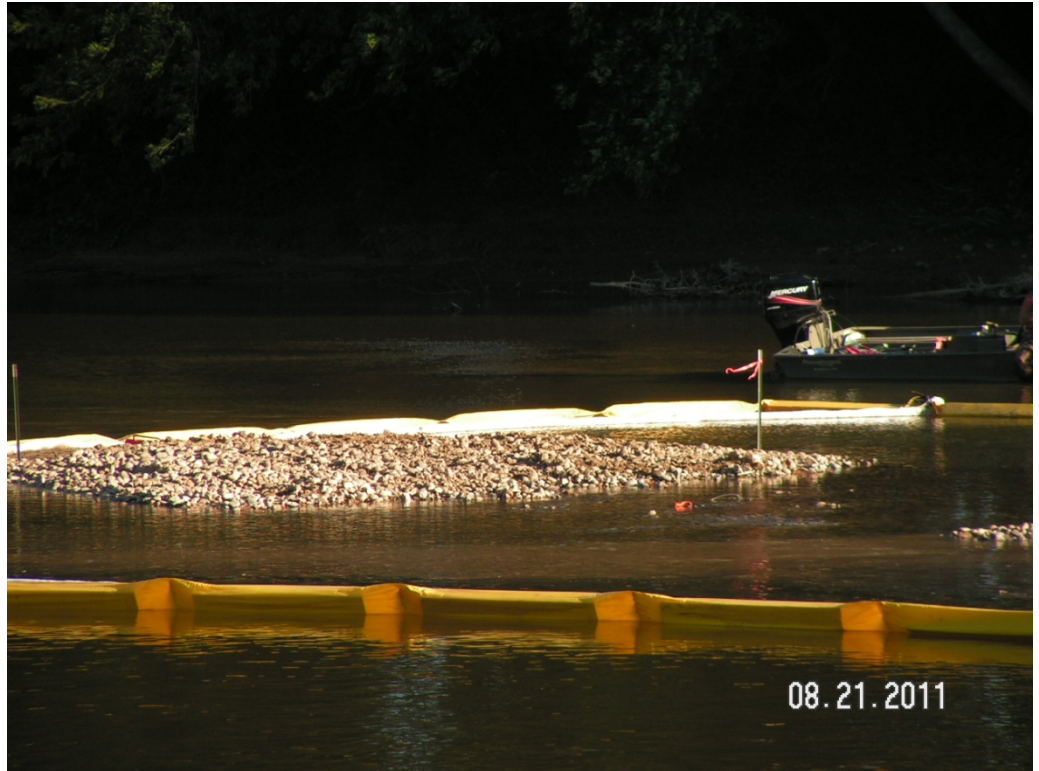
Downstream portion of capped area with armor stone

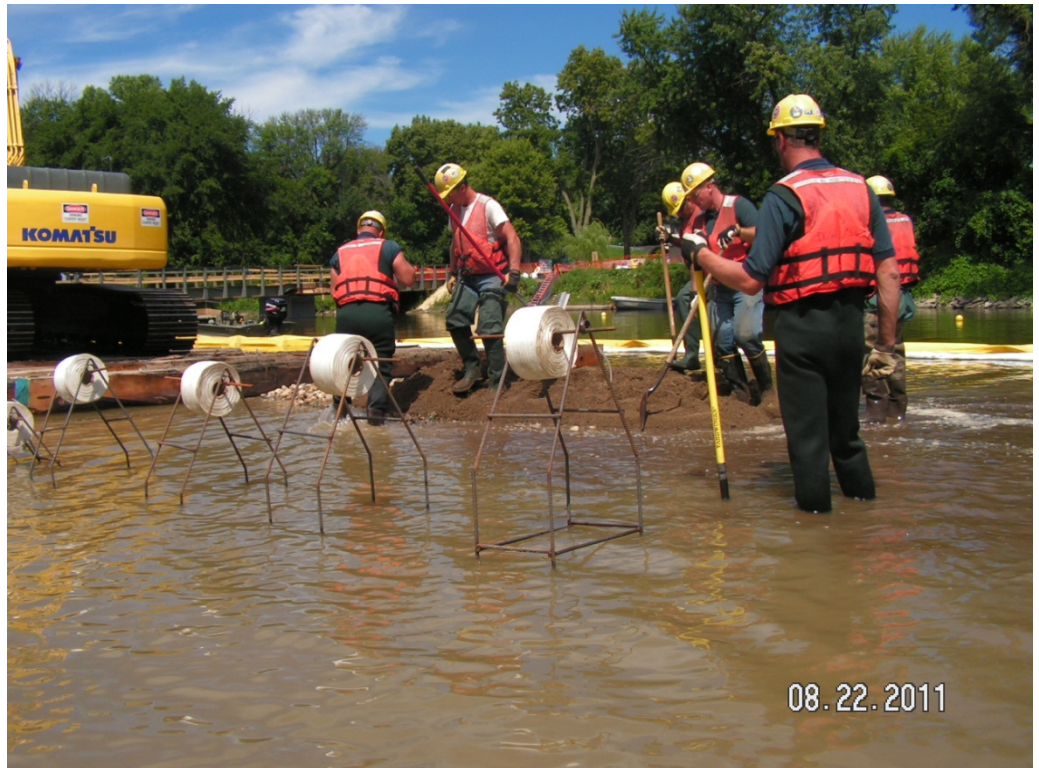
Photo No.
24

Placement of silty-sand material to reconstruct island. Nylon tendons on reels are for Geoweb installation.

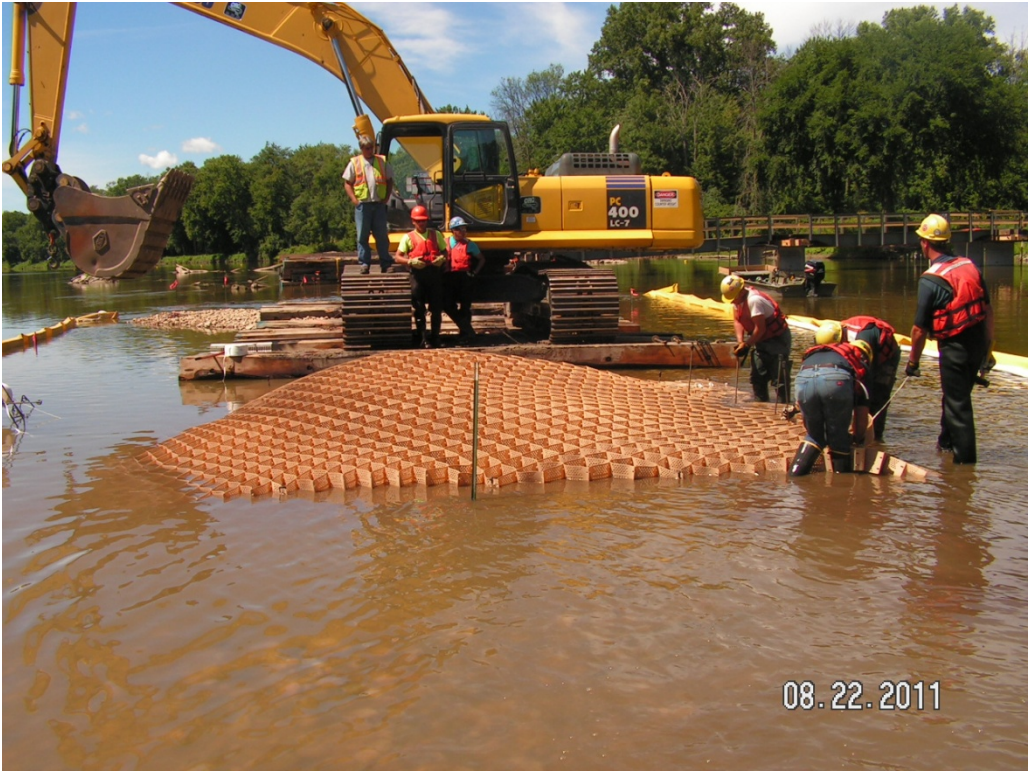
Client Name: Dow Chemical		Site Location: MM Island	Project No. 476
Photo No. 25	Date: 08/22/2011

<p>08.22.2011</p>	
Direction Photo Taken: West - upstream			
Description: Installation of GW-30V-6-08-29 Geoweb overtop of placed silty-sand material used to form the reconstructed island.

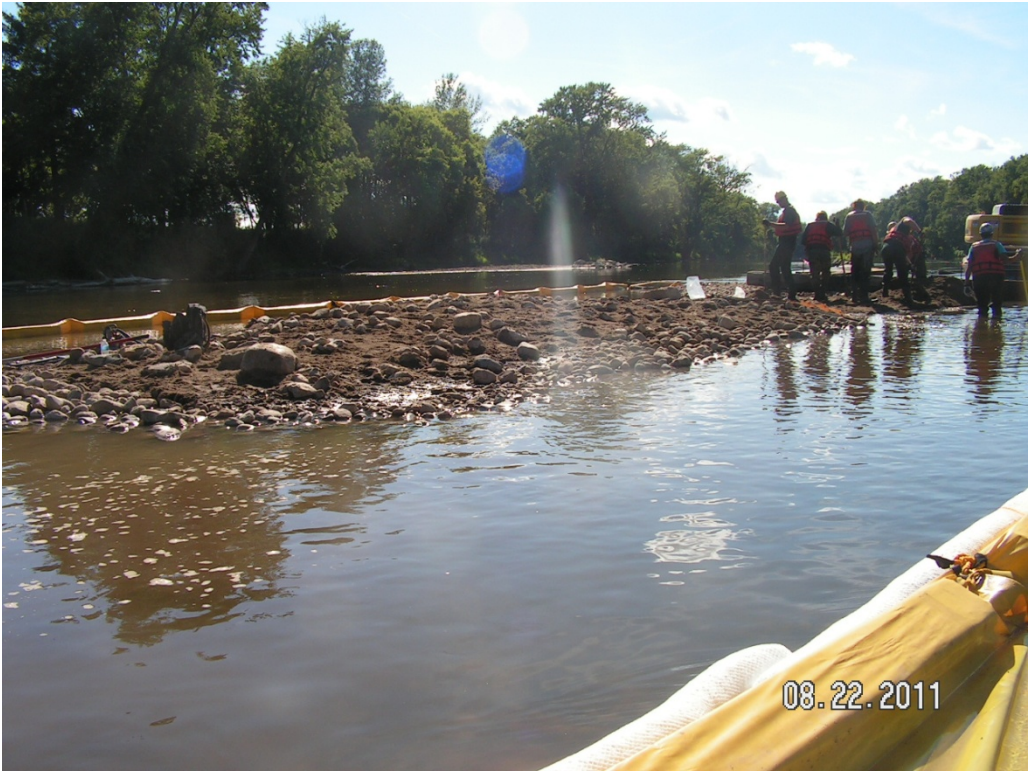
Client Name: Dow Chemical		Site Location: MM Island	Project No. 476
Photo No. 29	Date: 08/22/2011

<p>08.22.2011</p>	
Direction Photo Taken: Southwest			
Description: Downstream view of reconstructed island

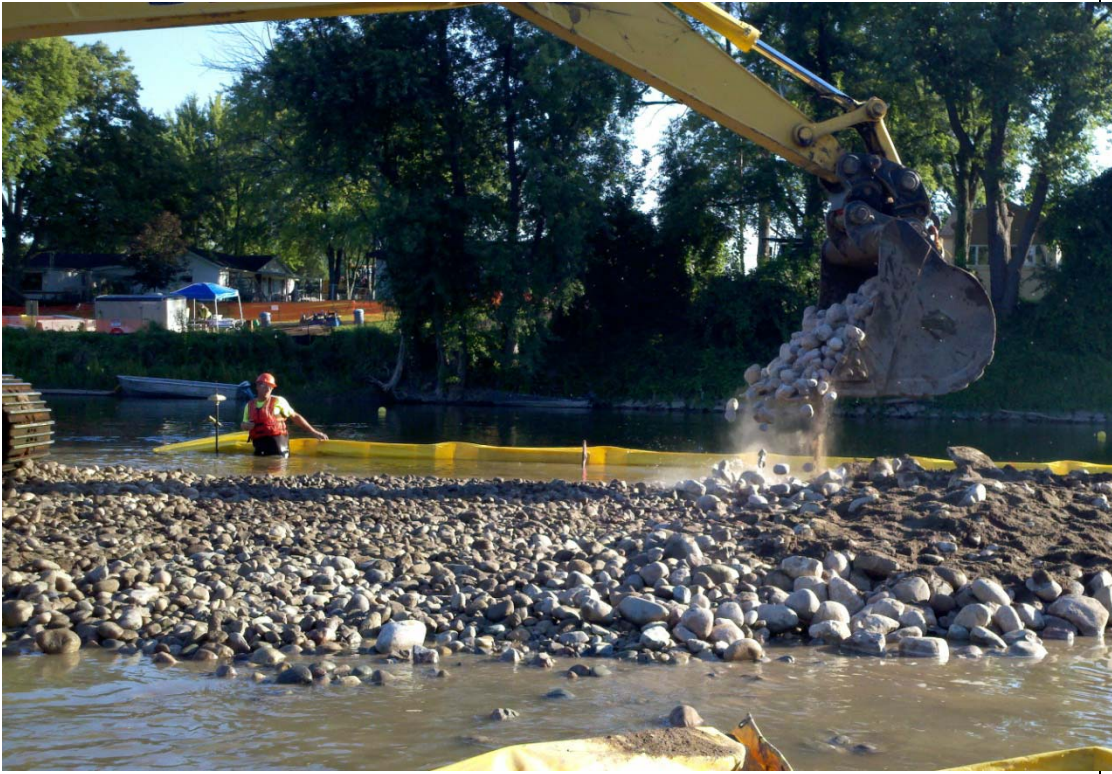
Client Name: Dow Chemical		Site Location: MM Island	Project No. 476
Photo No. 31	Date: 08/23/2011

Direction Photo Taken: North			
Description: Placement of 3- to 12-inch cobble armor on upstream portion of reconstructed island.

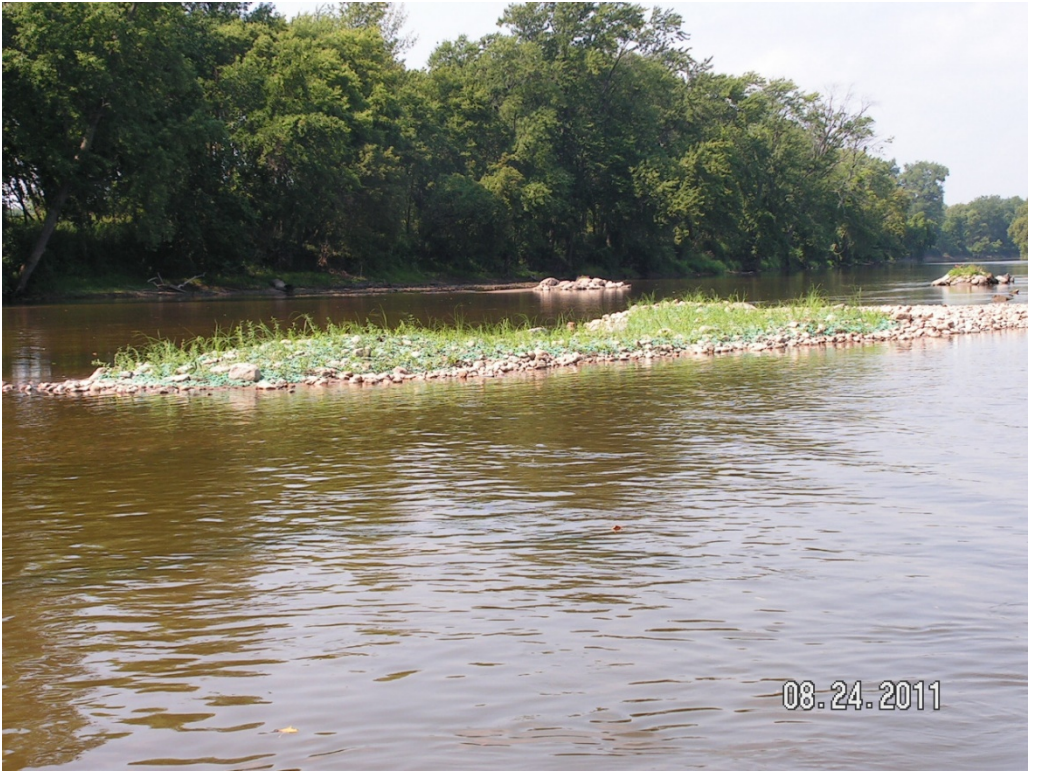
Client Name: Dow Chemical		Site Location: MM Island	Project No. 476
Photo No. 35	Date: 08/24/2011

<p>08.24.2011</p>	
Direction Photo Taken: Southwest			
Description: Reconstructed island complete.

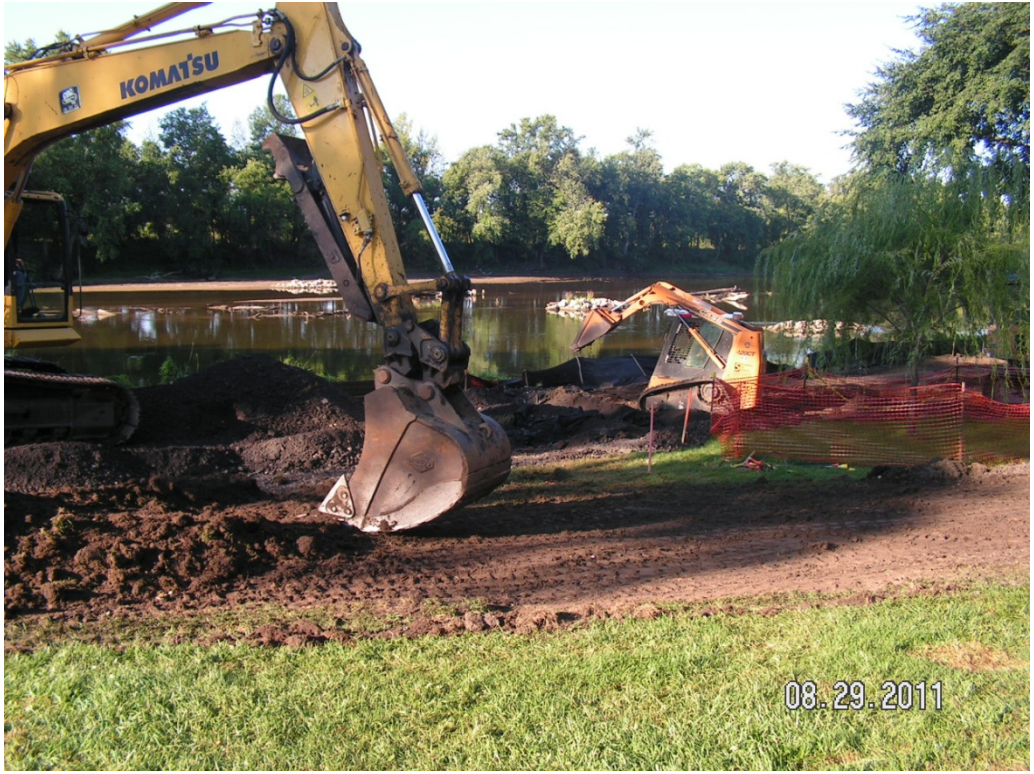
Client Name: Dow Chemical		Site Location: MM Island	Project No. 476
Photo No. 37	Date: 08/29/2011

Direction Photo Taken: Southwest			
Description: Removal of floodplain soils to prepare for sod installation.

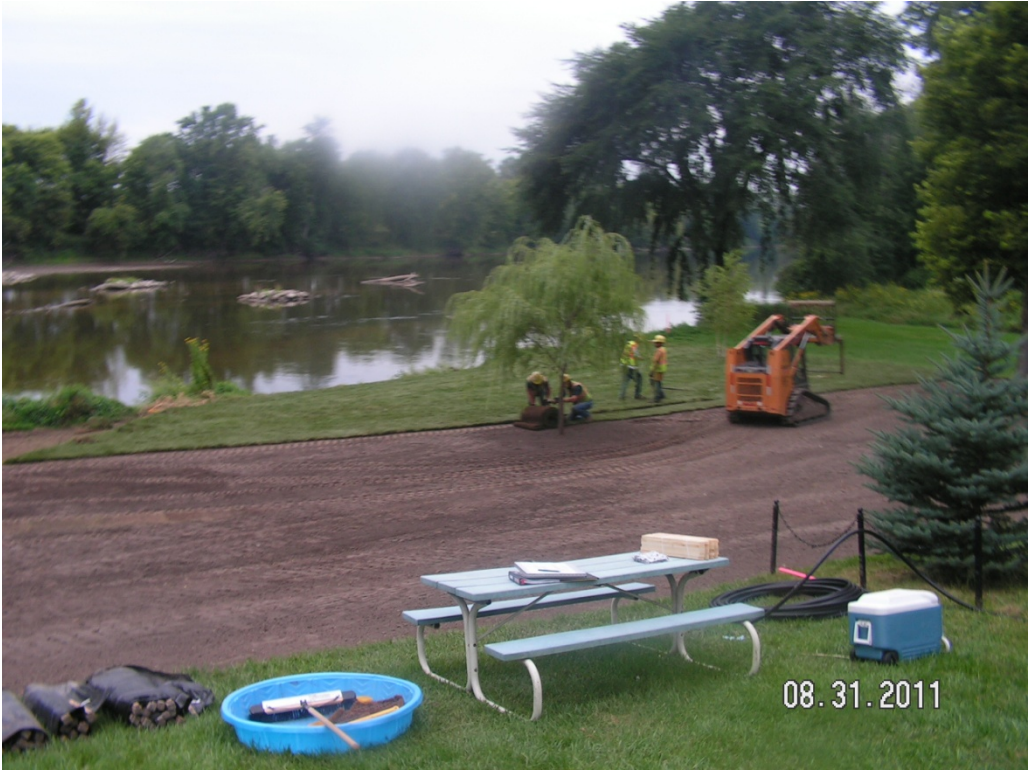
Client Name: Dow Chemical		Site Location: MM Island	Project No. 476
Photo No. 39	Date: 08/31/2011

Direction Photo Taken: Southwest			
Description: Installation of sod within floodplain.
